TMS TANKERS LTD

International Forum on STS
04th June 2019

TMS Tankers Sharing of Incidents

“Lifeboat damage during STS
Mooring operation”

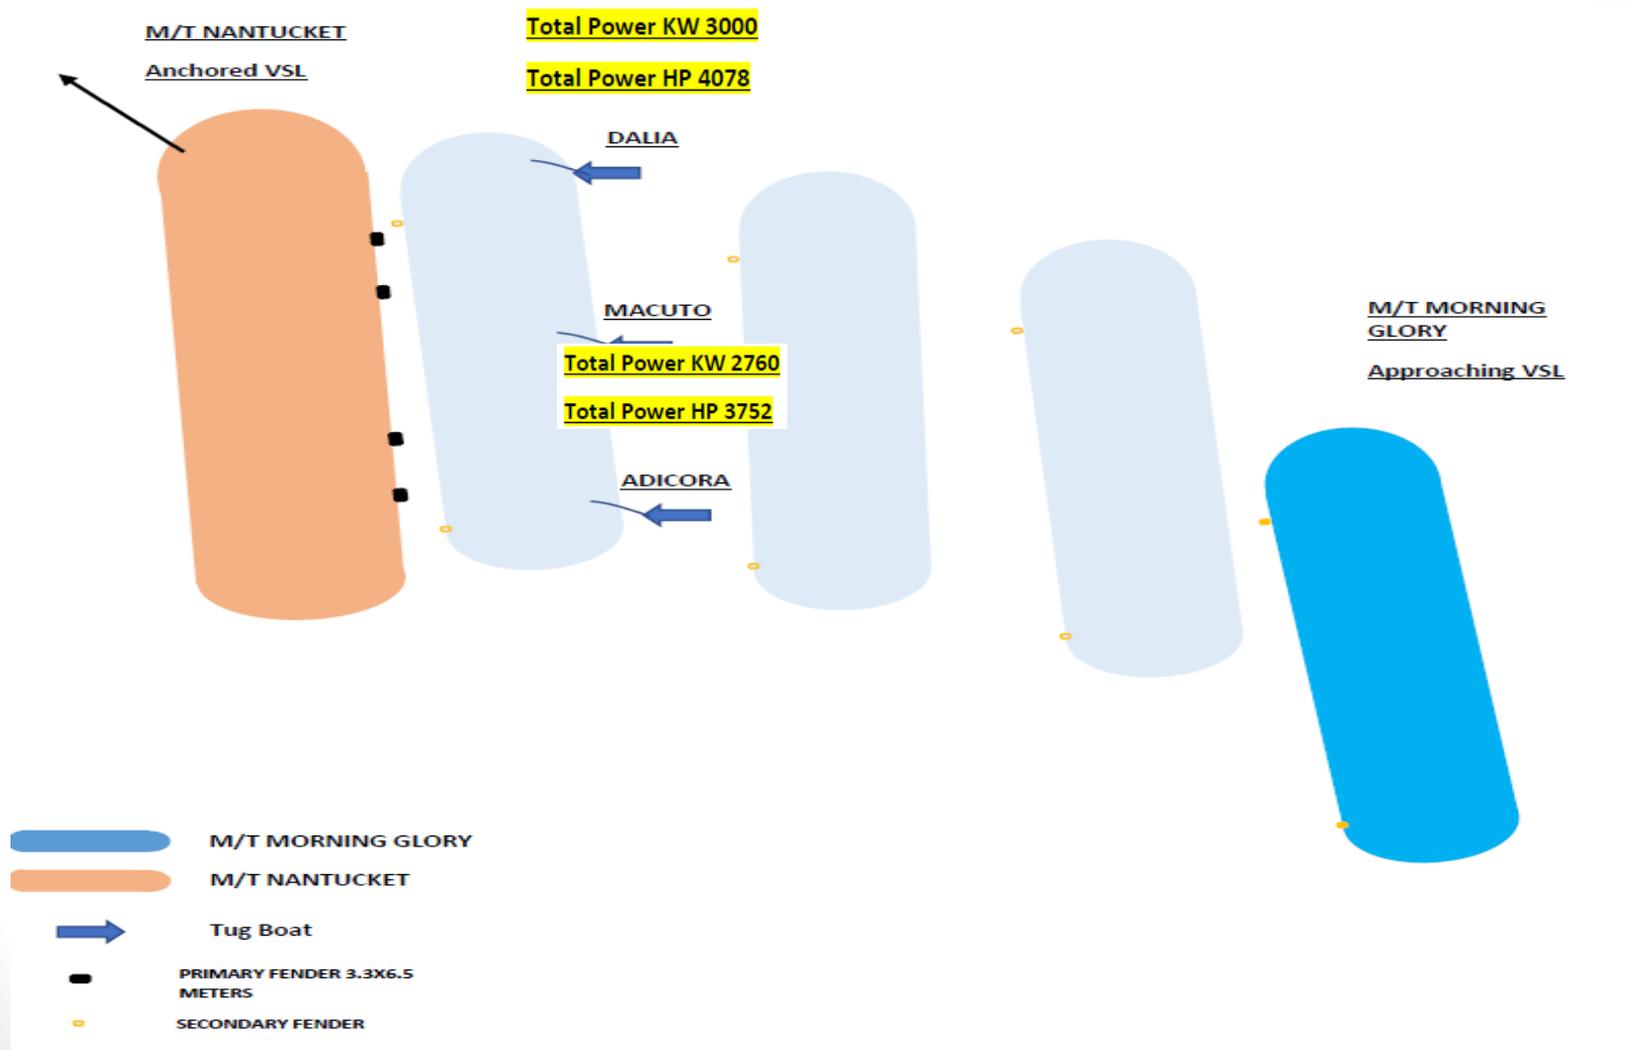
Sketch of the incident

The fwd bow tug was unable to provide adequate power once the fwd bow of M/T Morning Glory started to open, making larger angle and the 2 fwd lines were slacking. The sequence of the events led to small energy collision between a monorail crane of M/T Morning Glory and the Stbd lifeboat.
