INCIDENT ANALYSIS

Identifying the roots
OF AN INCIDENT

Incident details

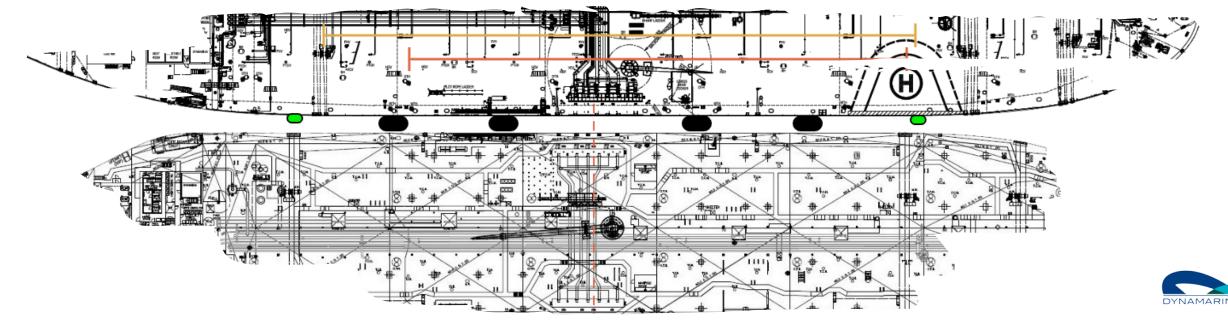
Correct fender positioning
