STS operations in Chittagong: Lessons learned

Modern challenges to STS operations

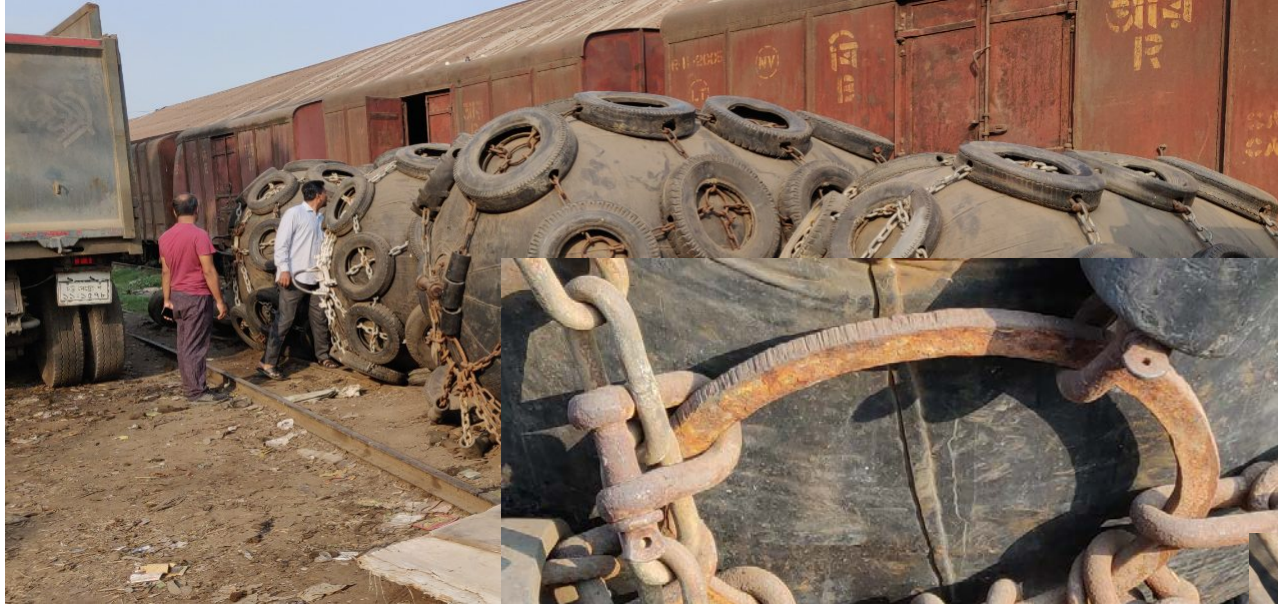
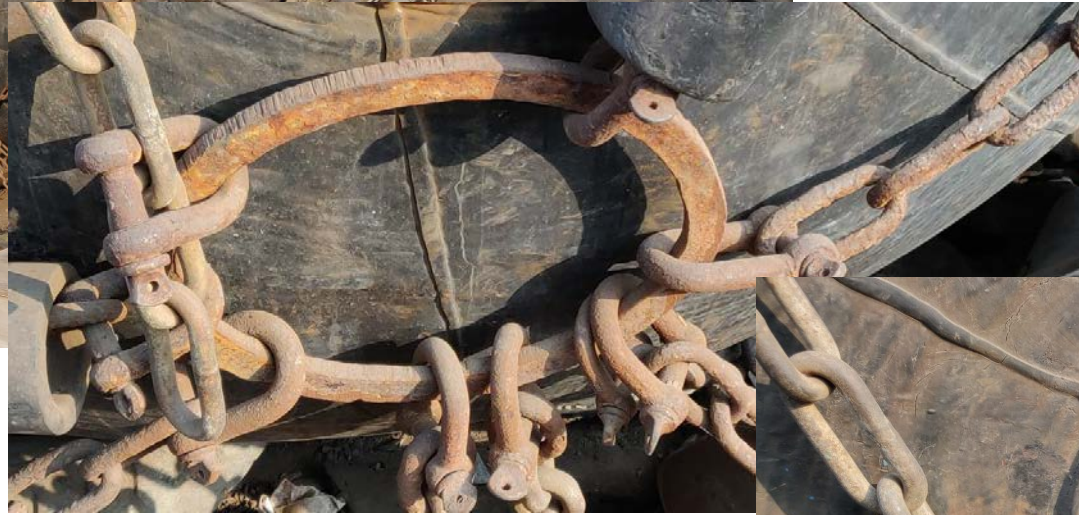
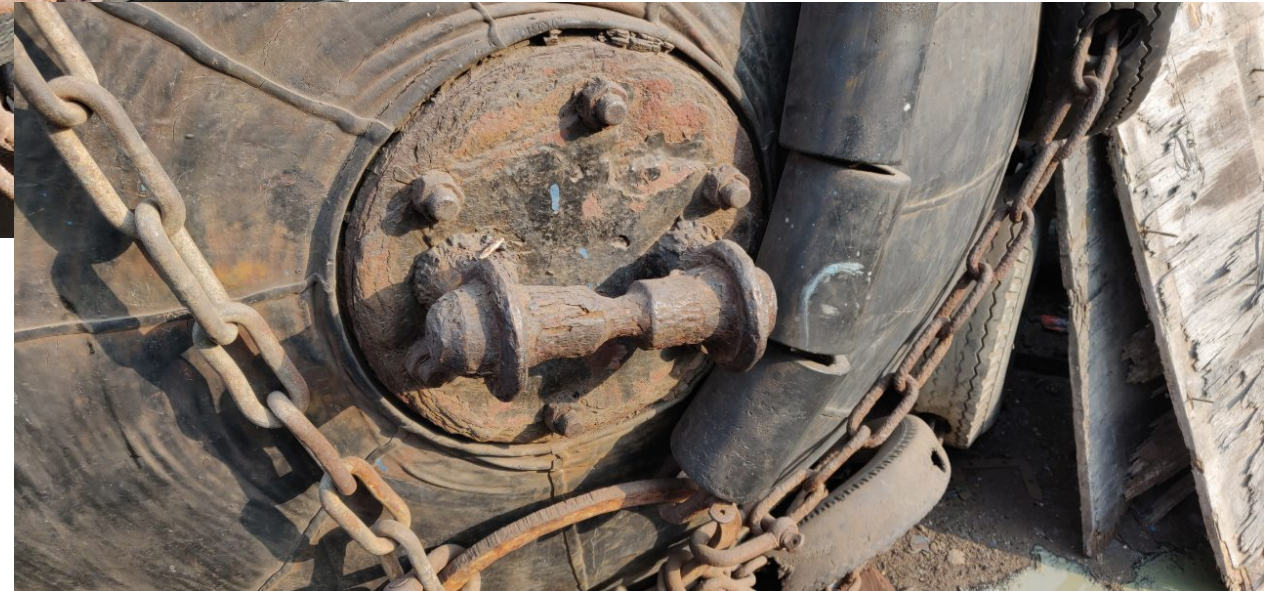
- Ⓢ The fenders evidenced at the yard were in a substandard condition. Condition of fenders included, without being limited to the following remarks:
 - Ⓢ a) The fenders were not YOKOHAMA, as mentioned at the relevant certificate provided by the supplier;

- Ⓢ b) The size shown at the certificate was incorrect;
 - Ⓢ c) The test pressure 200kPa shown at the certificate is unreasonable for the condition of fenders;

- Ⓢ d) The rubber connection seams of the fenders were in substandard condition;
 - Ⓢ e) Fender netting with associated chain and tyres was in substandard condition and maintenance should take place prior to deploying such fenders to operation;

- Ⓢ f) The safety valve and associated ending plate of some fenders were covered with rust, without any recent maintenance evidence;
 - Ⓢ g) Fenders were not stored in a safe and proper place;

- Ⓢ h) The fenders examined did not comply with ISO requirements and hence did not satisfy the requirements of (ICS/SIGTTO/OCIMF/CDI, 2013) section 9;

- Ⓢ i) The date of inspection of fenders did not correspond to the actual evidenced condition;

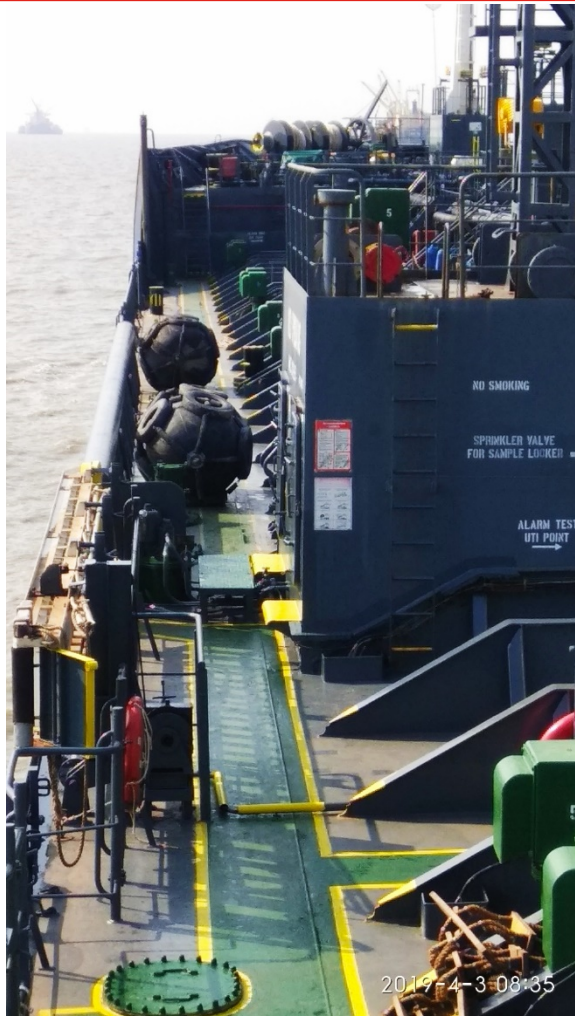
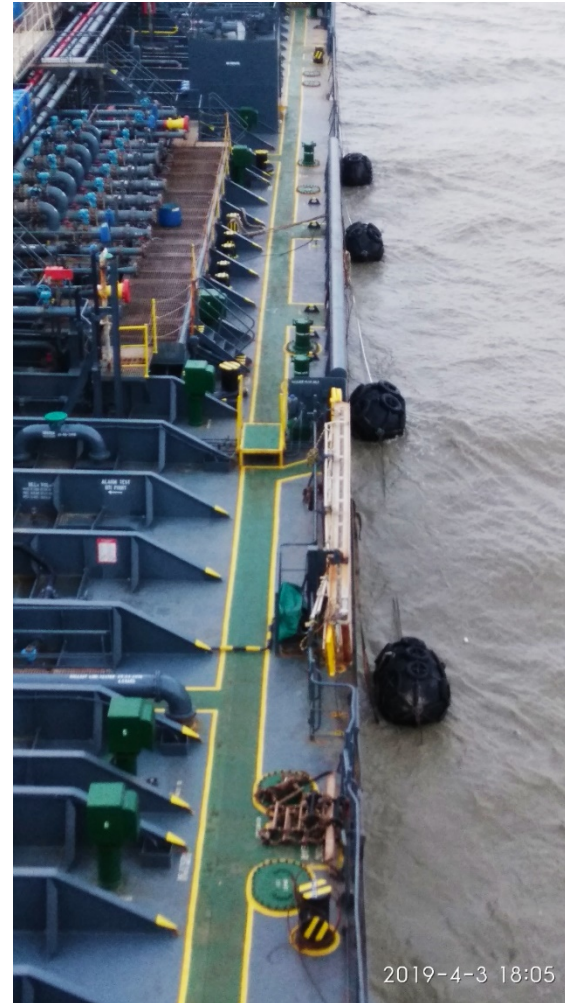
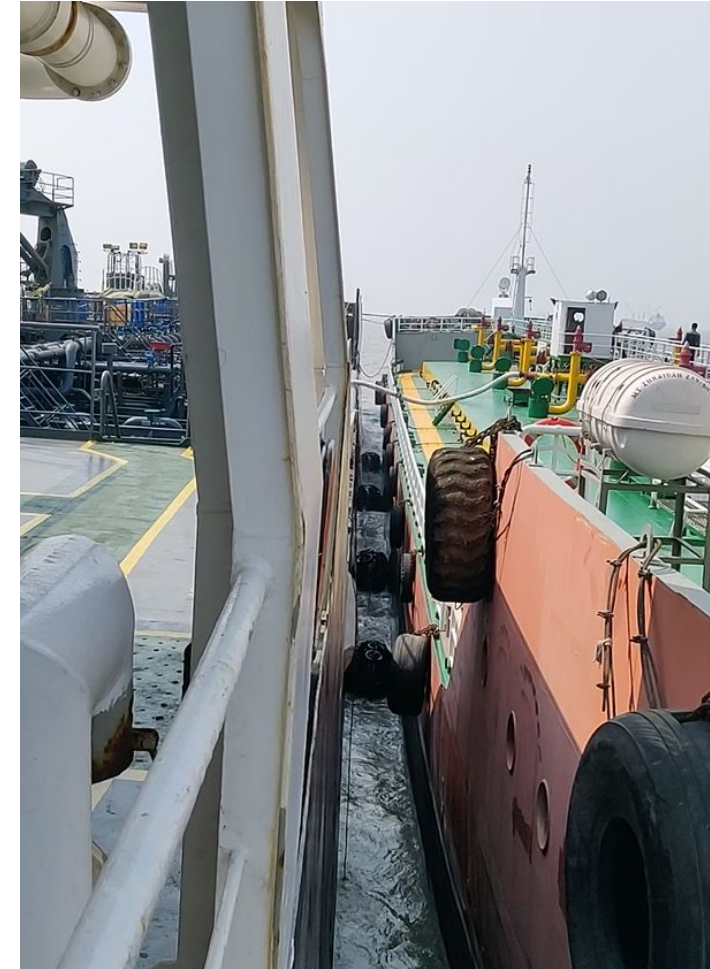
- ⑤ The parallel body of the DVs was equipped with small track tires. Owners insisted in the provision of proper pneumatic fenders, in order to be utilized at the parallel body of the MV. Such fenders arrived and deployed
- ⑤ The Fendering system was the following:
 - ⑤ Pieces: 4 baby fenders size utilized as primary fenders in order to match the parallel body.
 - ⑤ Size: 1.2mtrs Diameter x 2mtrs Length each fender
 - ⑤ Type: Pneumatic 50kPa
 - ⑤ Manufacturer: EVERGREEN
 - ⑤ Inspection standards: ISO 17357:2002
 - ⑤ Last inspection date: 16/08/2017

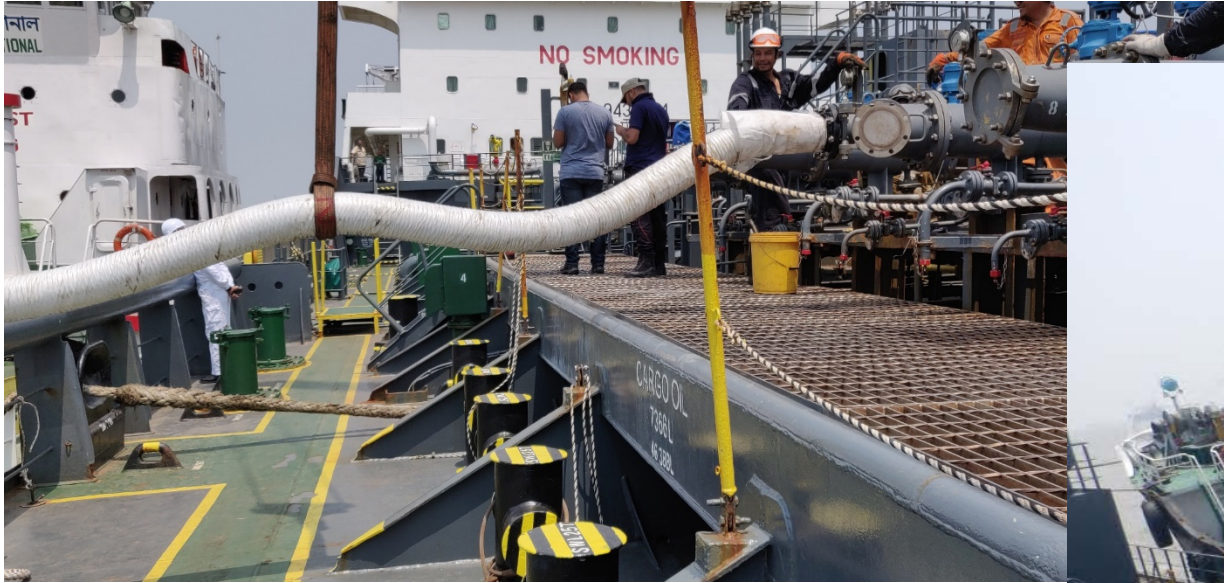
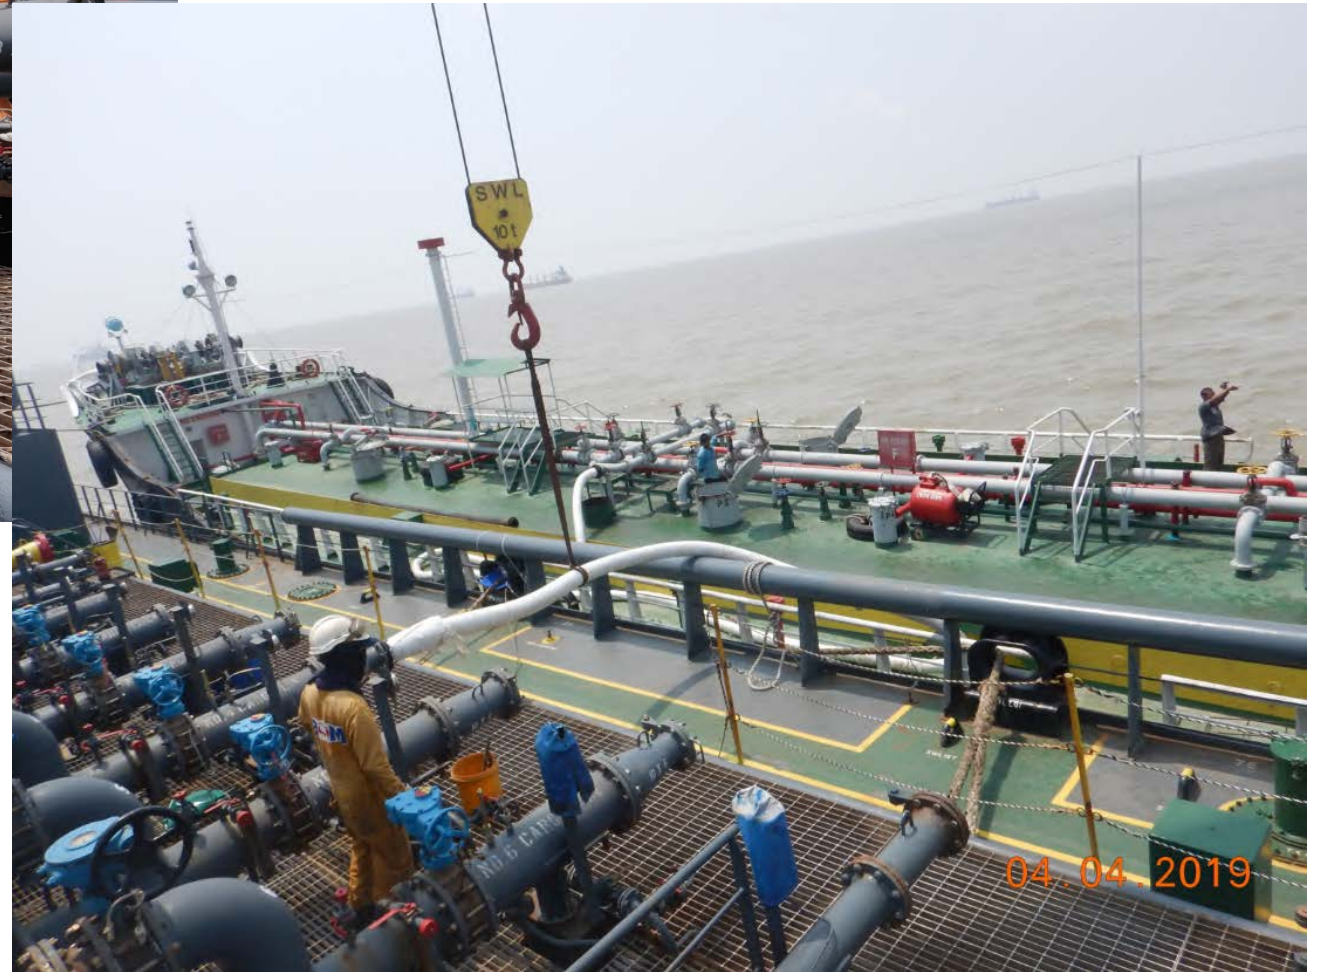
- Strings: 3 strings formulated a composite hose;
- Size: 6" x 9L x3(strings) , overall length of the hose: 27mtrs;
- Type: Composite;
- Cover: Plastic material;
- Max. working pressure: 16 Bar, as per provided hose description;
- Last time inspected: 09/01/2018;
